## Working group of the Director General of the National Heritage Institute for the renovation of the Vyšehrad Railway Bridge - Conclusions

April 15. – 16. 2026

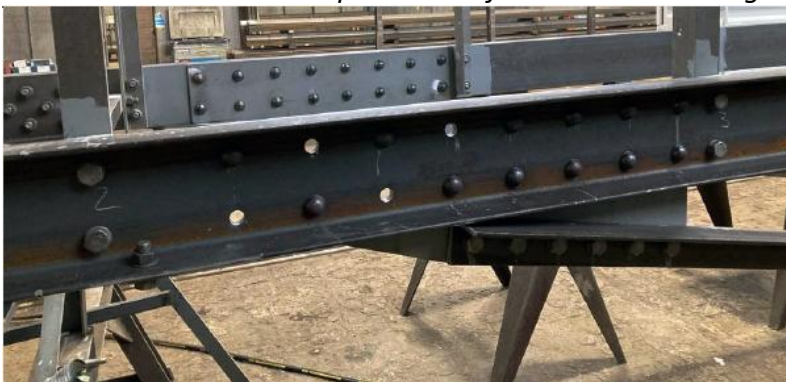
*Below: New riveting of components for a bridge in Switzerland, Schneider Stahlbau AG. Bolts are used to secure position of elements during riveting and then removed.*

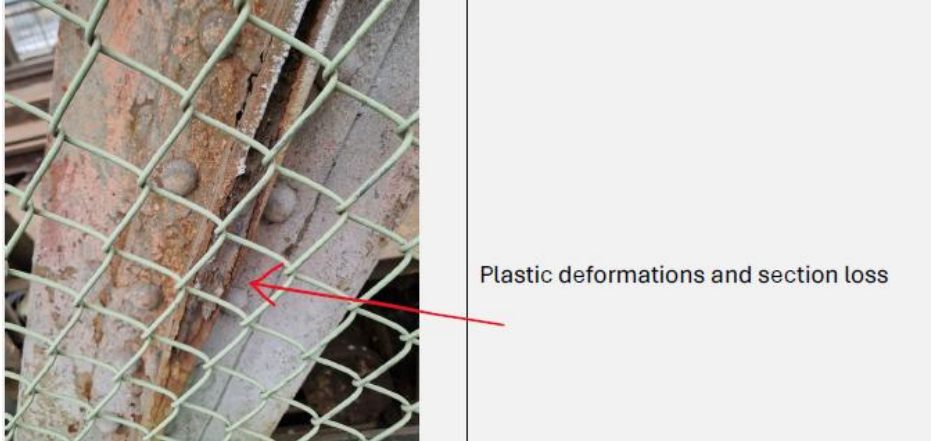
*Below is an example of a strongly deformed angle in the main truss diagonals*

In addition, an important aspect in the inspection of elements is that large plastic deformations in the elements, caused by the pressure in the crevices of the expanding corroding mass, should not be accepted: they indicate both a pre-damaged area that is particularly prone to further corrosion, are unlikely to be suitable for a thorough replacement

of the corrosion protection system, and – from a structural and material point of view - are potentially no longer sufficiently ductile steel elements.

Plastic deformations of the elements (e.g. of the flanges of an angle) that exceed that smaller value of  $1/25$  of the width or  $0.5x$  the plate thickness of the elements should not be accepted and the corresponding elements should be replaced.
